NASA Contractor Report 166011

DESIGN, ANCILLARY TESTING, ANALYSIS, AND FABRICATION DATA FOR THE ADVANCED COMPOSITE STABILIZER FOR BOEING 737 AIRCRAFT

VOLUME II—FINAL REPORT

BOEING COMMERCIAL AIRPLANE COMPANY
P.O. BOX 3707, SEATTLE, WA 98124

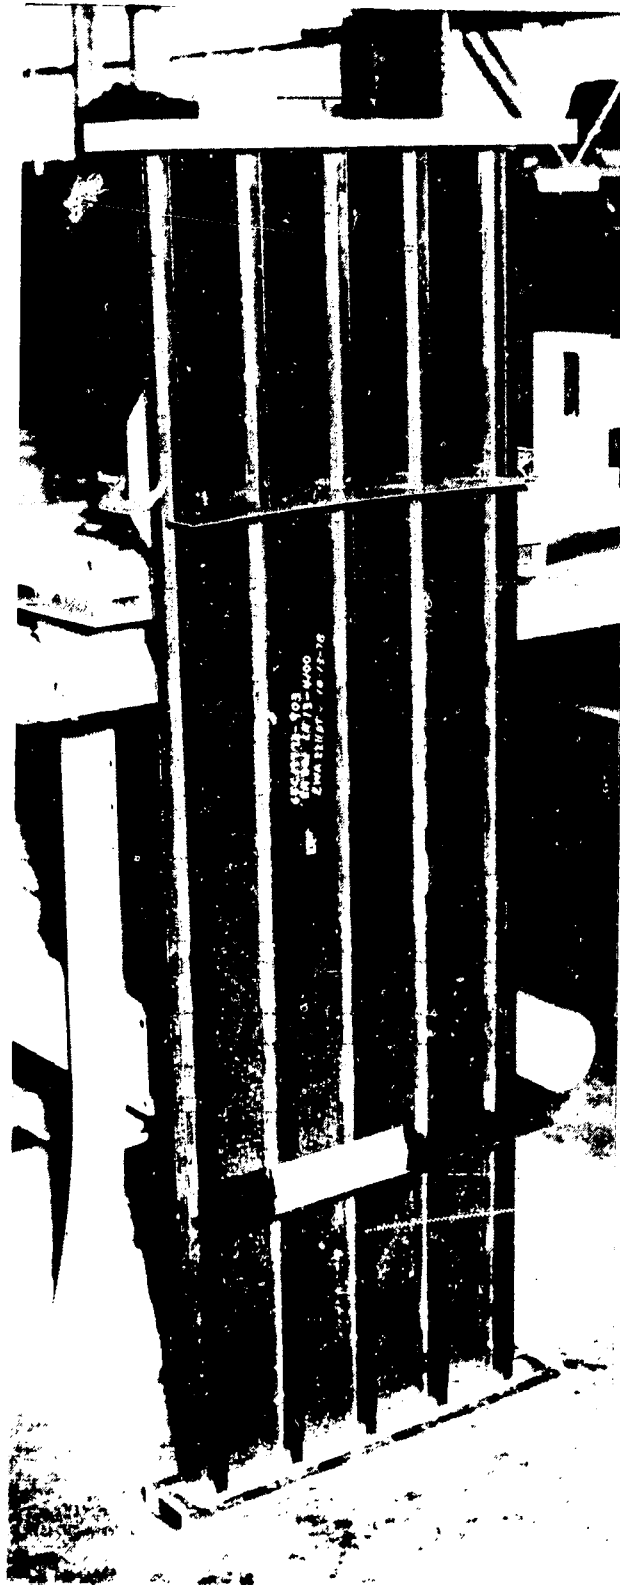
Figure 80. Compression Test Panel (Test 10)

Five-stringer compression test panels from Test 10 were tested to verify Euler column buckling characteristics of the stabilizer skin/stringer system. The results are presented in Table 11, and the panel definition is shown in Figure 79. The potted ends of the specimen are shown in Figure 80. Figure 81 defines the strain gage and deflection indicator locations. Figures 82 and 83 present deflection data for Configurations 1 and 2, respectively. Strain plots for the center stringer and skin panel at the panel midlength position are shown in Figure 84 for the Configuration 1 panel, and Figure 85 presents a typical result for Configuration 2 at the same location.

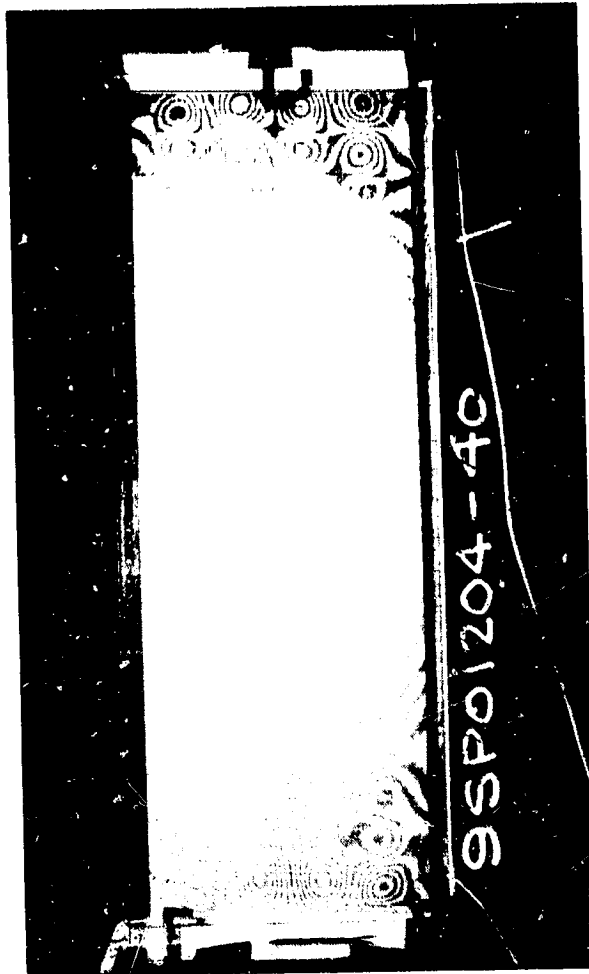
Figure 86. Moire Fringe Photo of Compression Specimen 65C17773-1 at 133.4-kN (30-kips) Load (Test 10)

The strain plot for the Configuration 1 panel (fig. 84) indicates that the skin panel between stiffeners buckled at an average strain of approximately -0.0017 mm/mm (in/in). This result agrees closely with the data for the 65C17773-61 crippling panel (fig. 75). The Moire fringe photo of the Configuration 1 panel (fig. 86) shows the well-developed buckle pattern at 133.4-kN (30-kips) load. The Moire fringe photo also shows the reduction of buckle deformation in the skin pad-up areas at the rib locations.

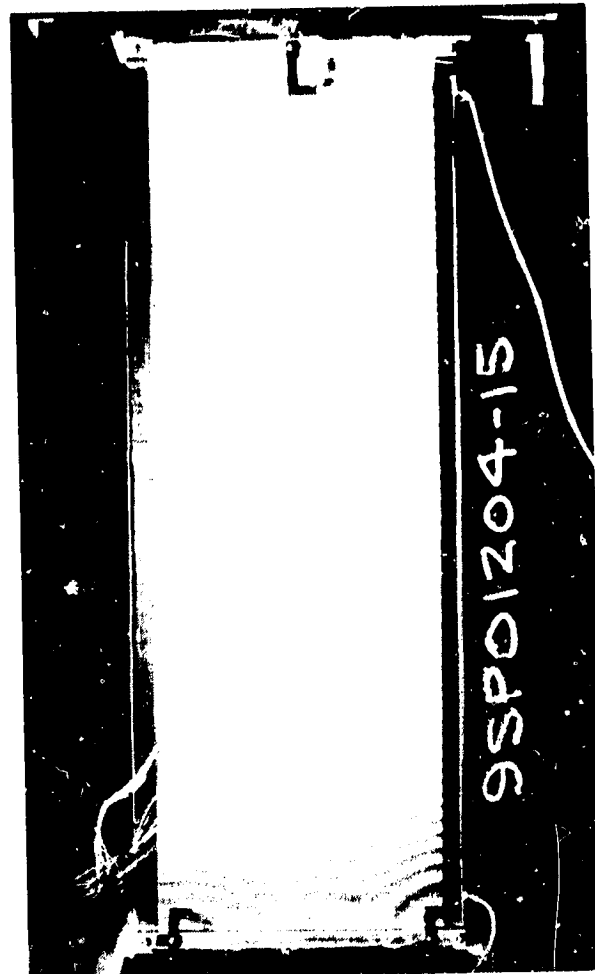
Figure 87. Moire Fringe Photo of Compression Specimen 65C17773-2 at 169-kN (38-kips) Load (Test 10)

The strain plot for the Configuration 2 panel (fig. 85) indicates that the skin panel did not buckle prior to column failure. This result agrees with the 65C17773-62 crippling panel test (fig. 77). The Moire fringe photo of the Configuration 2 panel at 169 kN (38 kips) (fig. 87) confirms the absence of a well-defined buckle pattern.

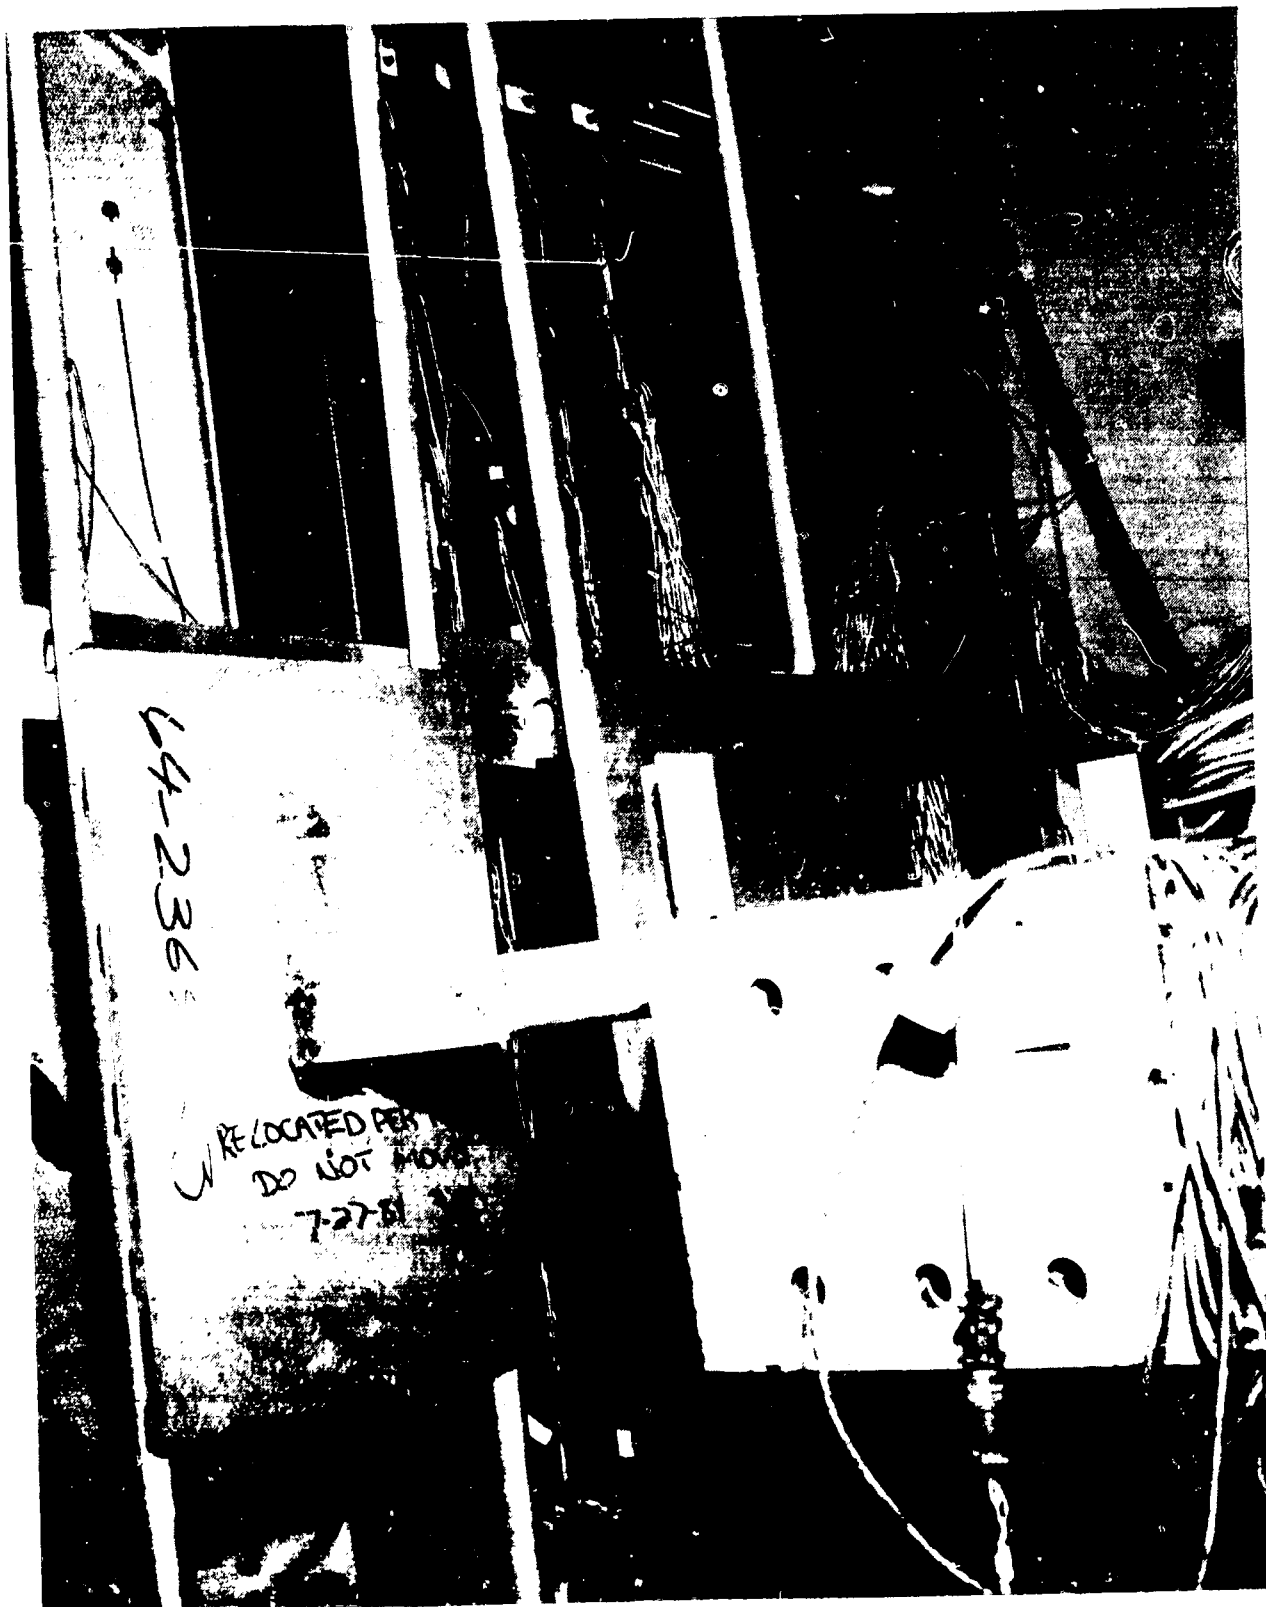
Figure 166. Test Setup

The test panel, assembled and ready for test, is shown in Figure 166. Testing was conducted according to the plan contained in Table 34. Cold tests were conducted at -59°C (-75°F), which was obtained by circulating liquid nitrogen through the environmental chamber. A wet condition was created by exposing the specimen to 60°C (140°F) and to 80% to 85% relative humidity until the specimen weight stabilized, as determined by a standard moisture rider. Hot-wet testing then was conducted by raising the temperature to 82°C (180°F), zeroing the gages, and applying ultimate load.

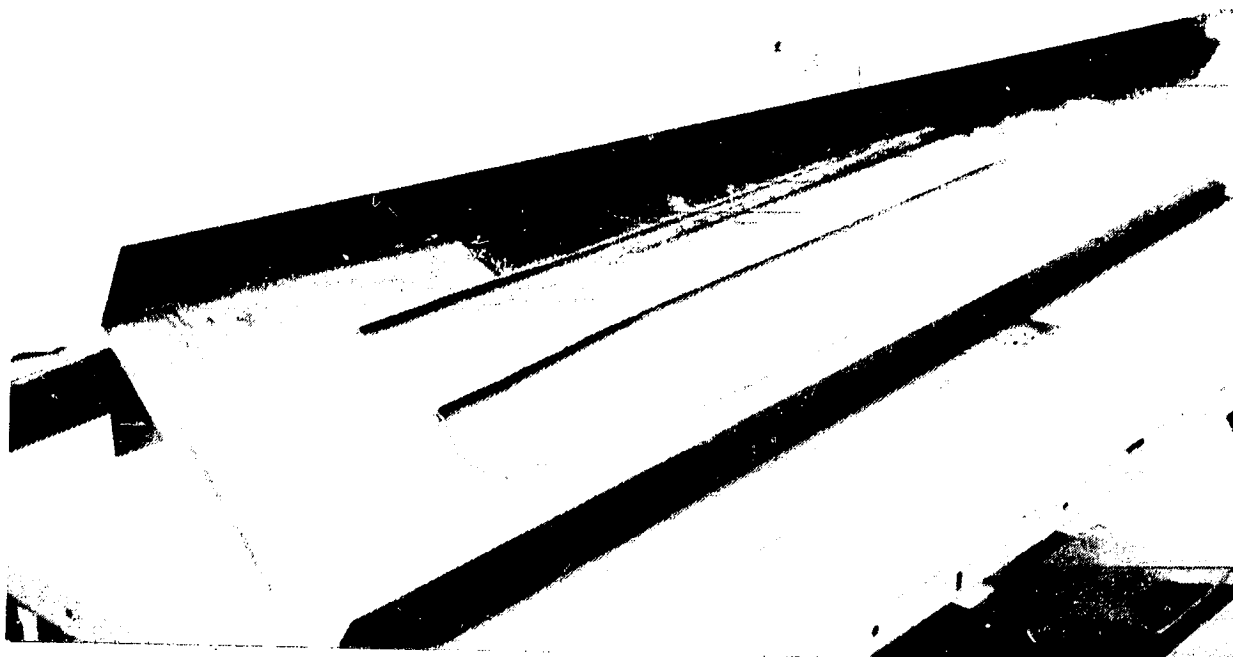
Figure 195. Completed Spar Lug Feasibility Part

- Layup and cure of prebond details (figs. 177 through 180)
- Layup for the bonding operation including defect incorporation (figs. 181 through 195)
- Verifilm determination of adhesive bondline thickness and uniforming; Figures 196 through 200 illustrate the Verifilm process
- Bonding operations; Figure 201 illustrates both bonding operations and includes Verifilm determination of cap/web bondlines
- Machining of titanium straps
- Profile milling lug area (fig. 202)
- Bonding titanium straps (figs. 203 and 204)
- Drilling and fastener and bushing installation (figs. 205 through 207)

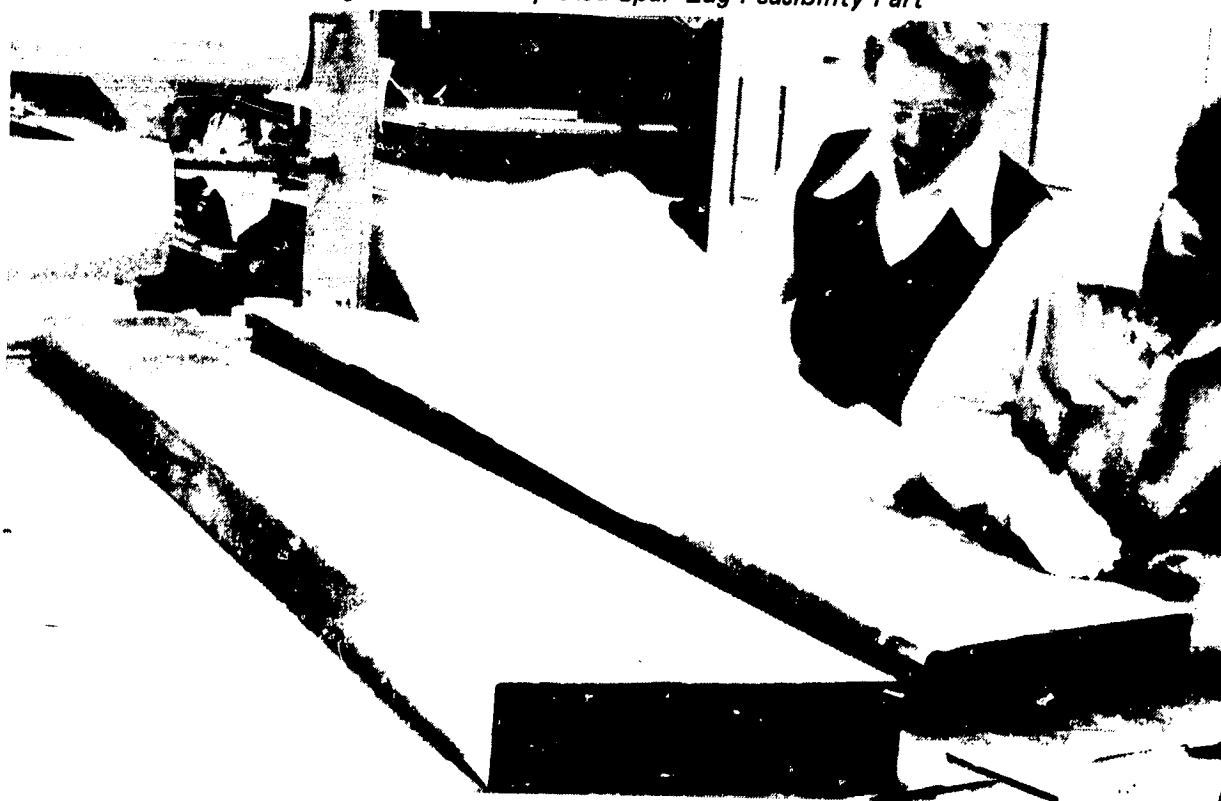
Figure 196. Verifilm Positioned on Detail Part

Verifilm, a fluorinated ethylene propylene (FEP) film used to evaluate adhesive films and to prevent adhesion during simulated cure cycles, is illustrated in Figures 196 through 199. The contrast in appearance of the two adhesives is shown in Figure 200. This test established that precured spar webs and spar caps would bond with an acceptable bondline thickness variation and an absence of porosity or voids in the adhesive film. The adhesive used to bond the producibility part and

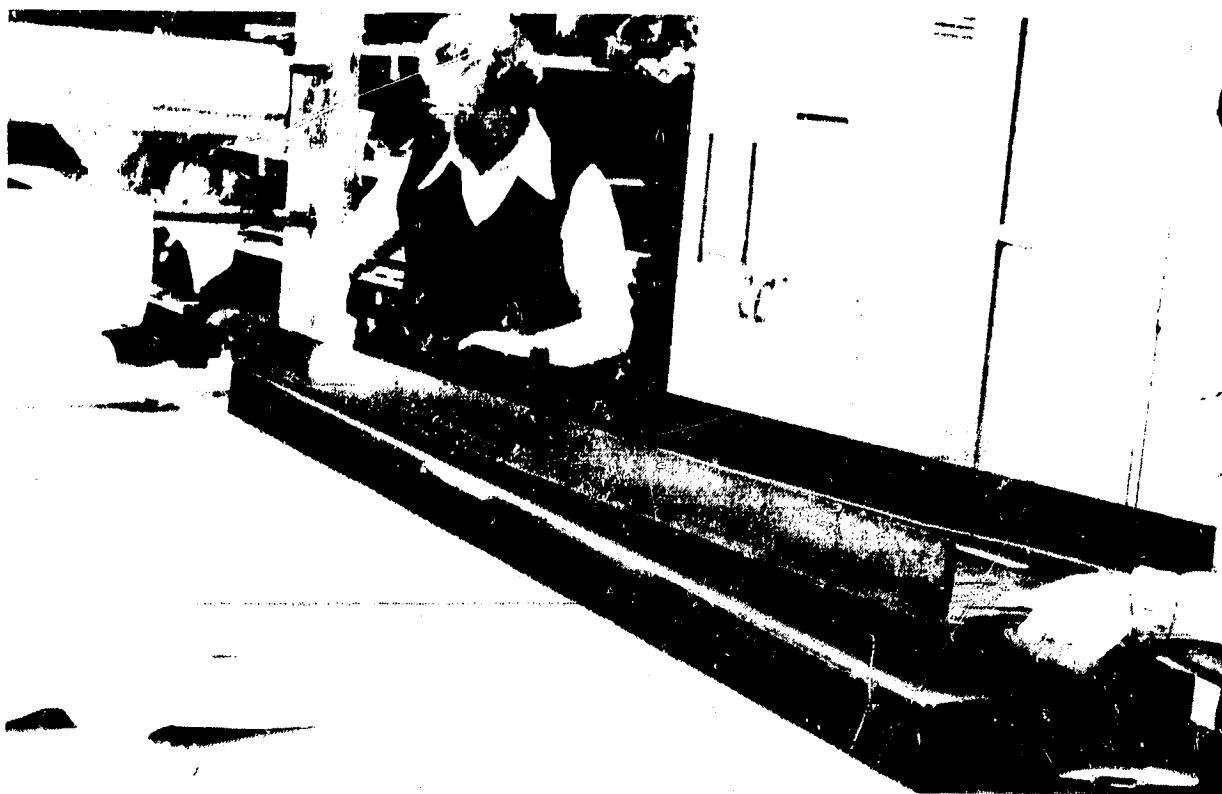
Figure 197. Bond Surfaces Aligned

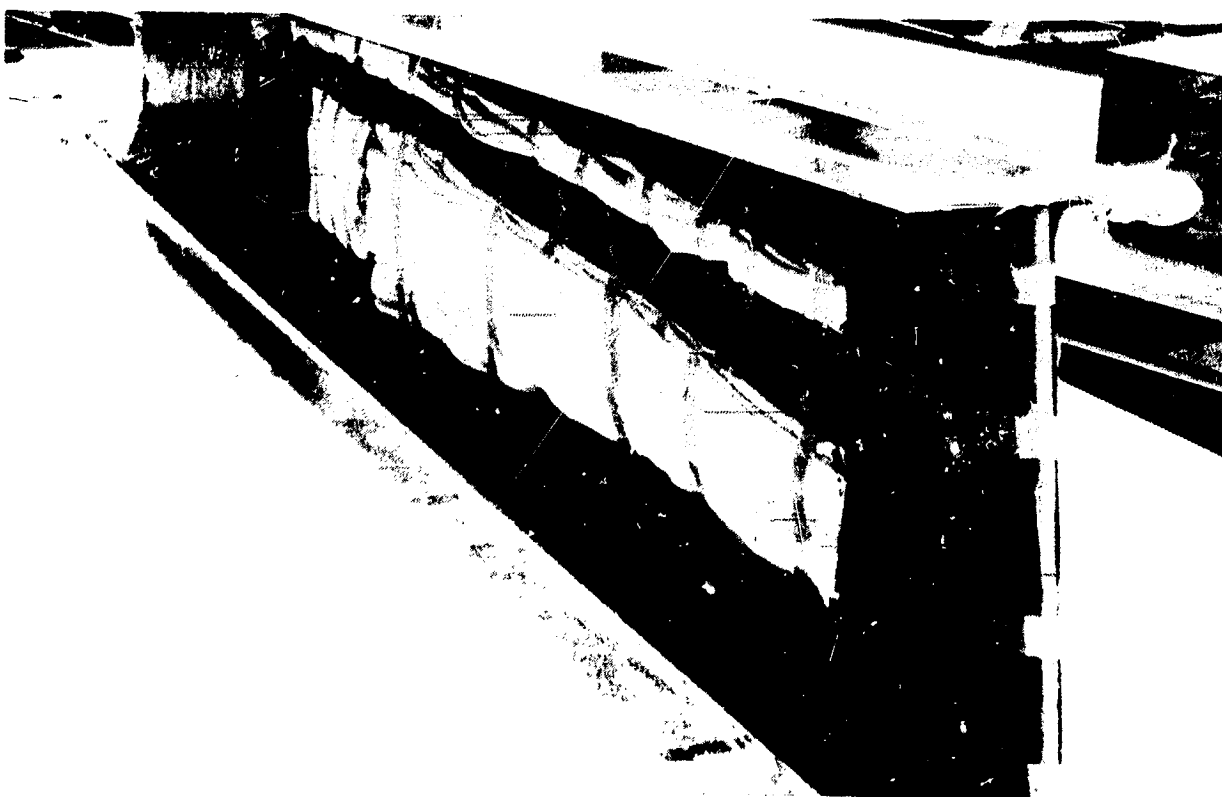
Figure 198. Bond Surfaces Together—Ready for Bagging

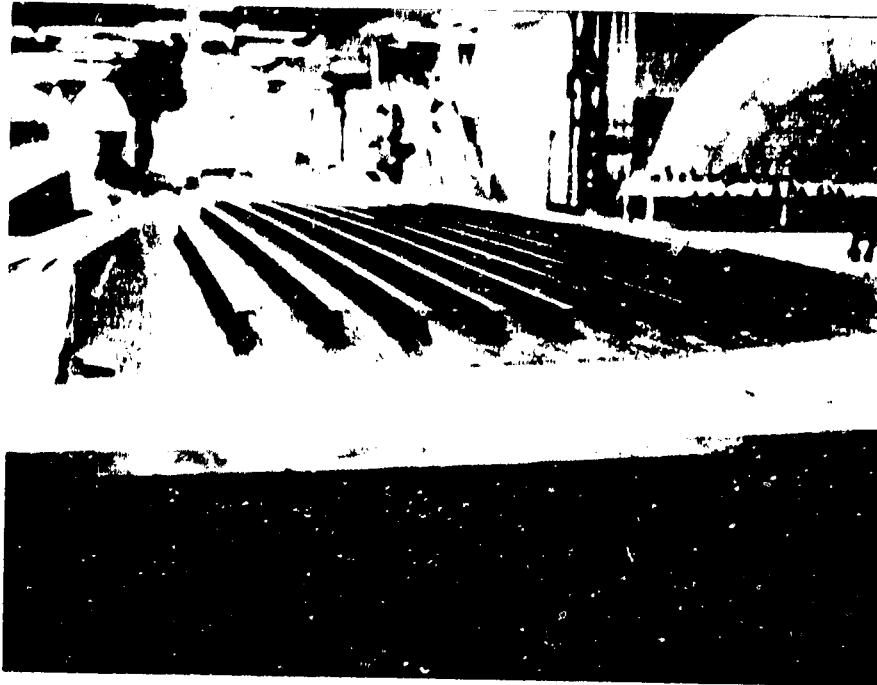
Figure 217. I-Stiffened Panel Section Made for Warpage Study (Test 10)

I-Stiffened Panels—Figures 169 and 215 through 220 show details of the test assembly fabrication (Test 10).

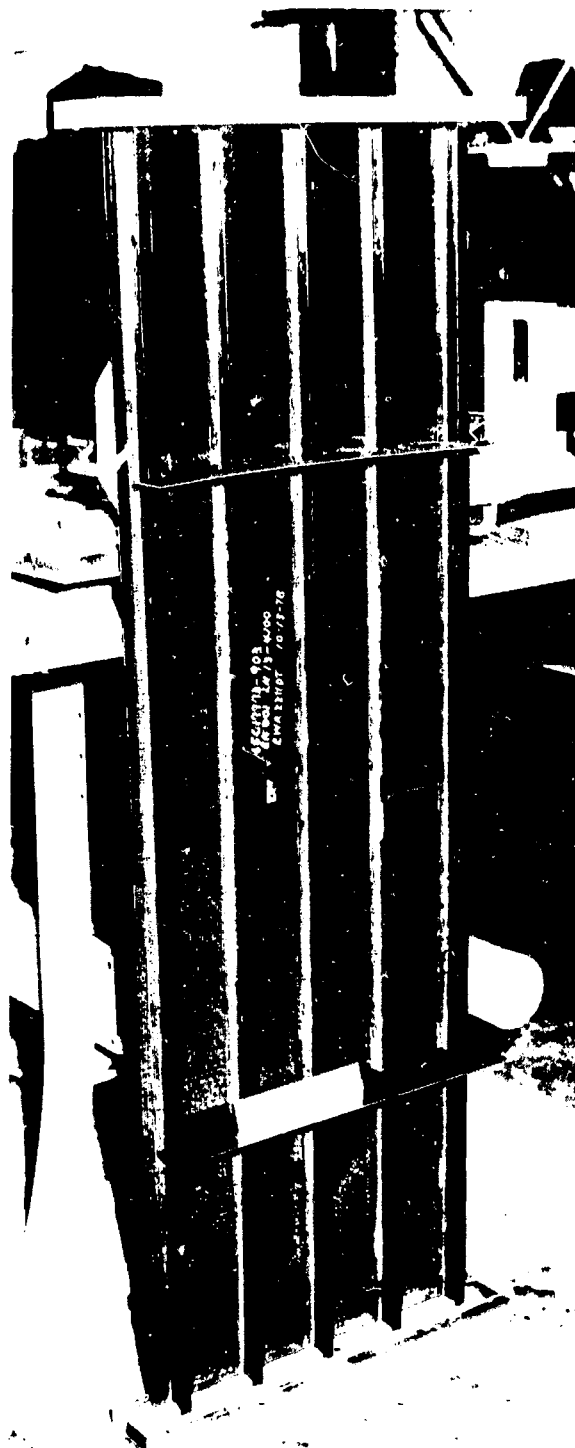
*Figure 220. Compression Test Panel—Stiffened
Side (Test 10)*

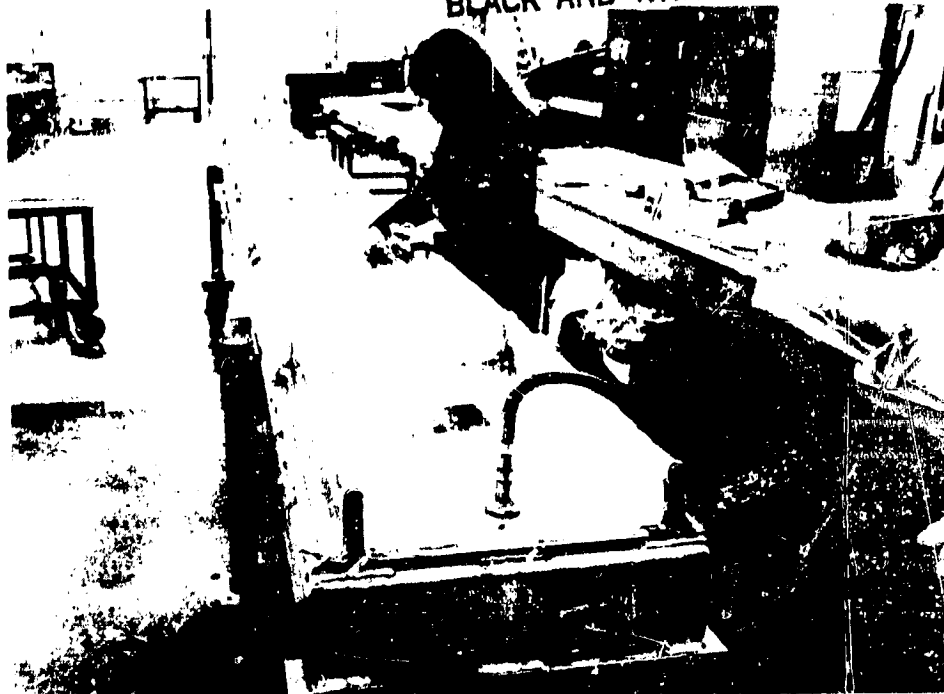
Figure 223. Spar Lug—Specimens Ready for Cure (Test 12)

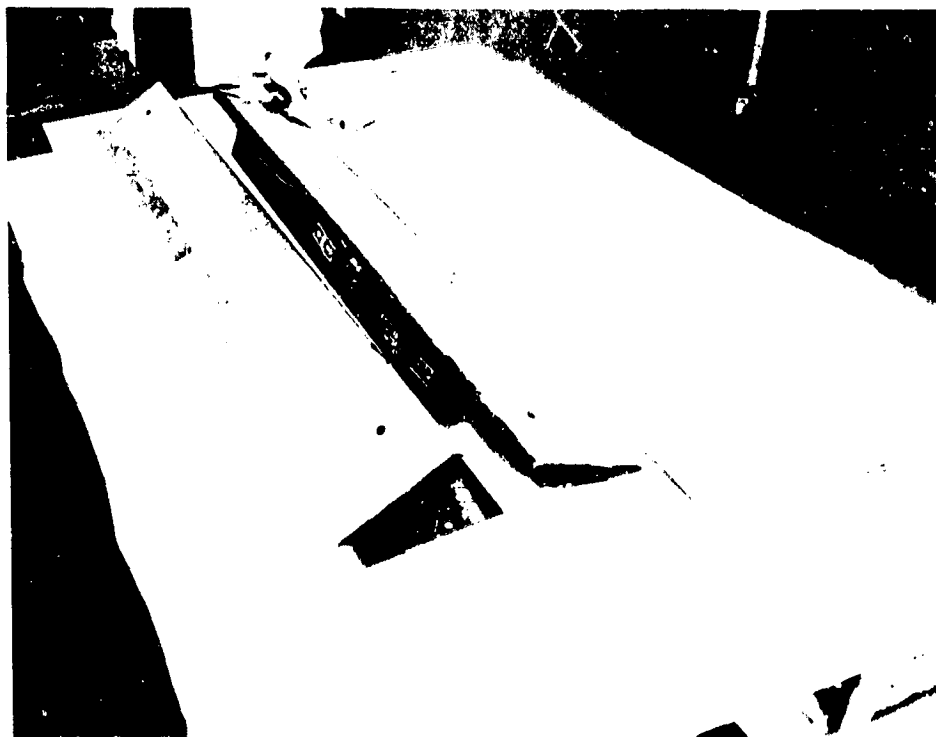
Figure 224. Spar Lug—Peel Ply Being Removed From Completed Detail Halves (Test 12)

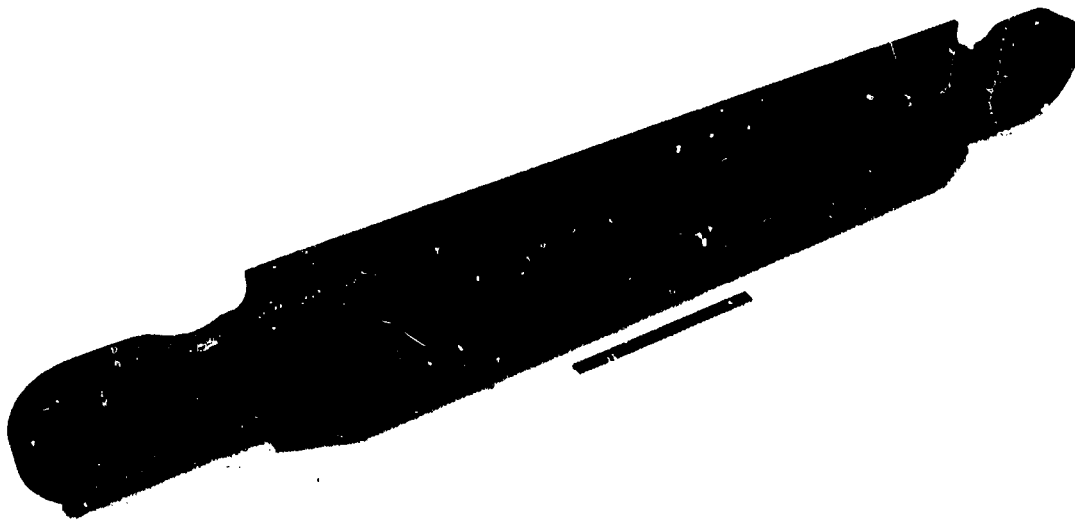
Figure 227. Spar Lug—Trimmed Tension Specimen (Test 12)

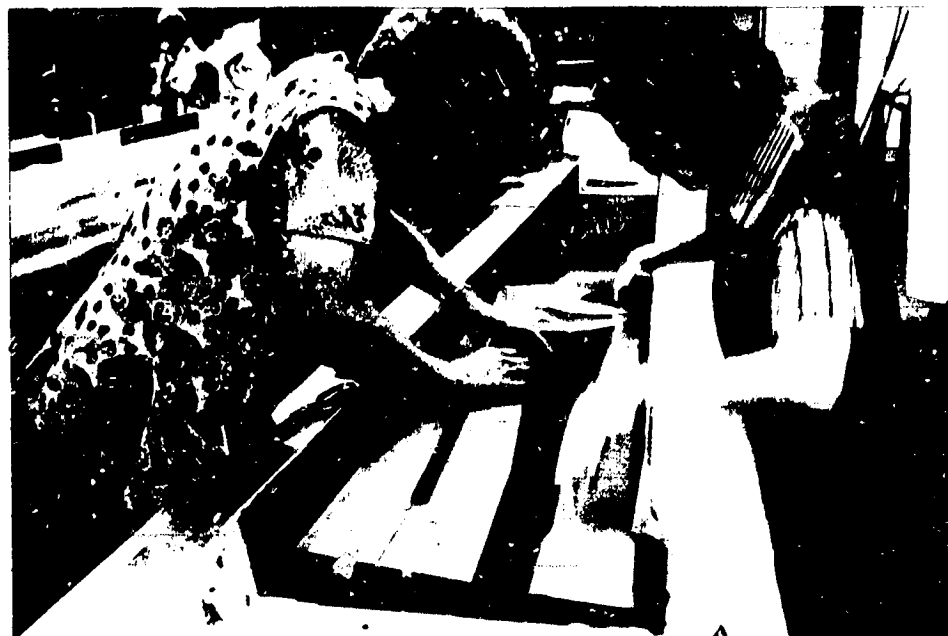
Figure 231. Stub Box Rear Spar—Incorporation of Precured Insert Into Layup (Test 21)

Stub Box—This test part was produced as manufacturing verification hardware and is discussed in Section 5.3 and illustrated in Figures 231 through 254 (Test 21).

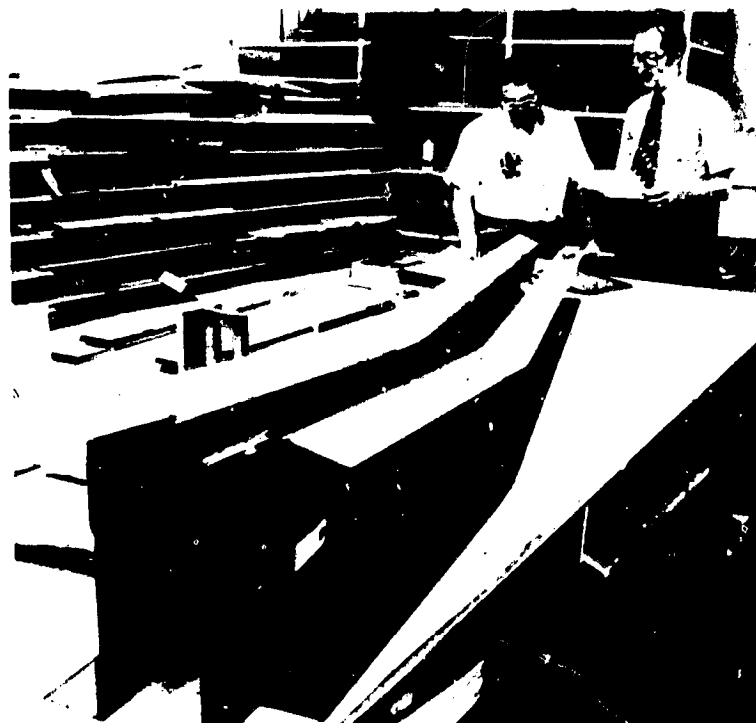
Figure 232. Stub Box Front Spar—Completed Details Being Inspected (Test 21)

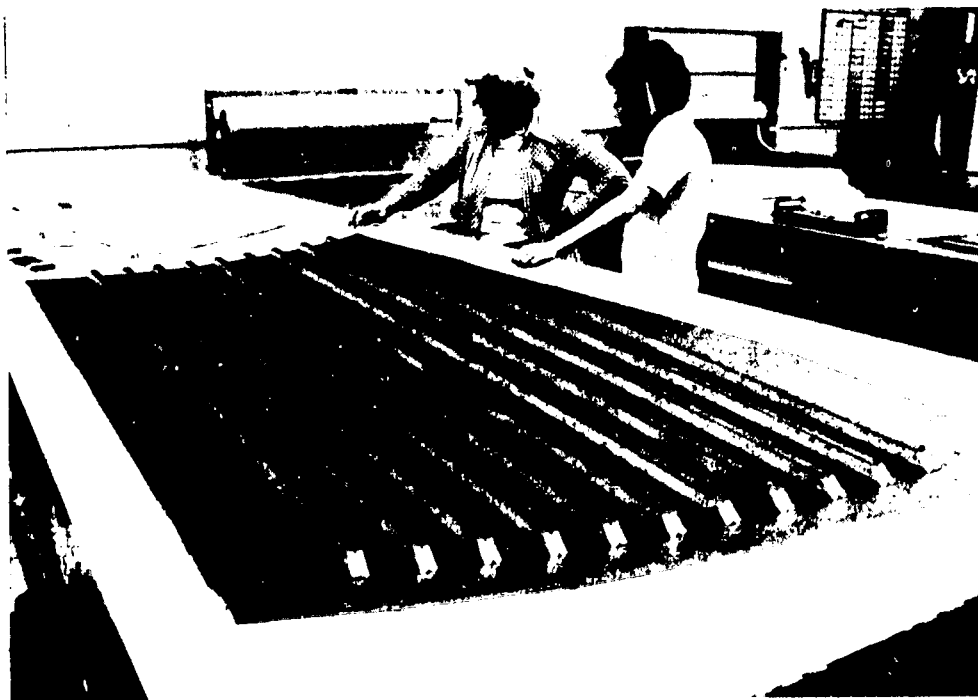
Figure 236. Stub Box I-Stiffened Skin Panel—All I-Stiffeners in Place (Test 21)

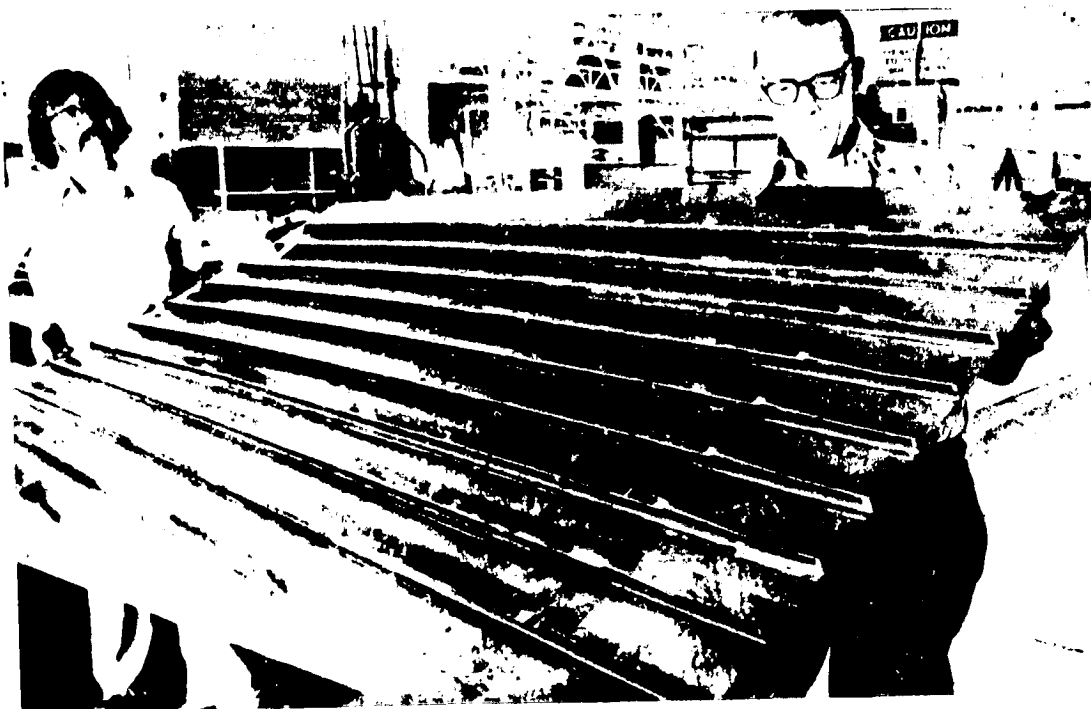
Figure 240. Stub Box I-Stiffened Skin Panel—Trimmed Part (Test 21)

I-Stiffened Skin Panel Fabrication—Production of the verification I-stiffened skin panels for the Test 21 stub box showed that problems existed with excessive porosity on the panel tool surface and with panel warpage in excess of 1.40 cm (0.55 in).

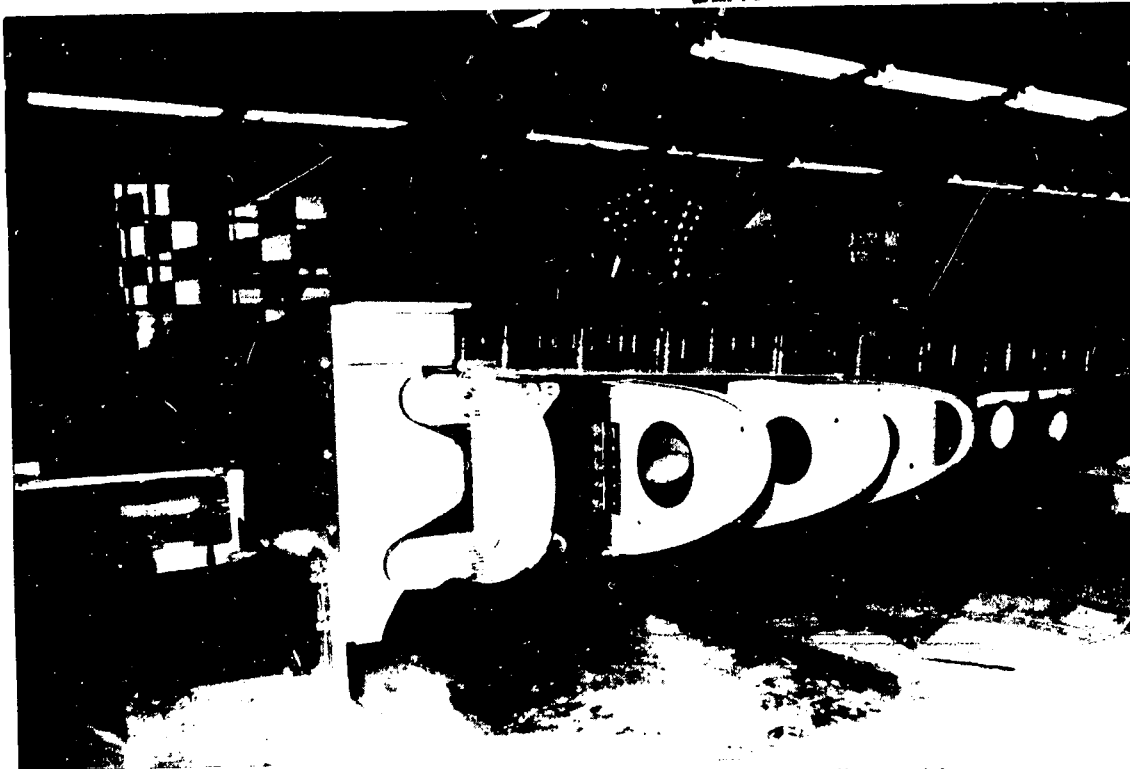
Figure 247. Stub Box—Front Spar, Aluminum Nose Ribs, and Lower Skin in Place (Test 21)

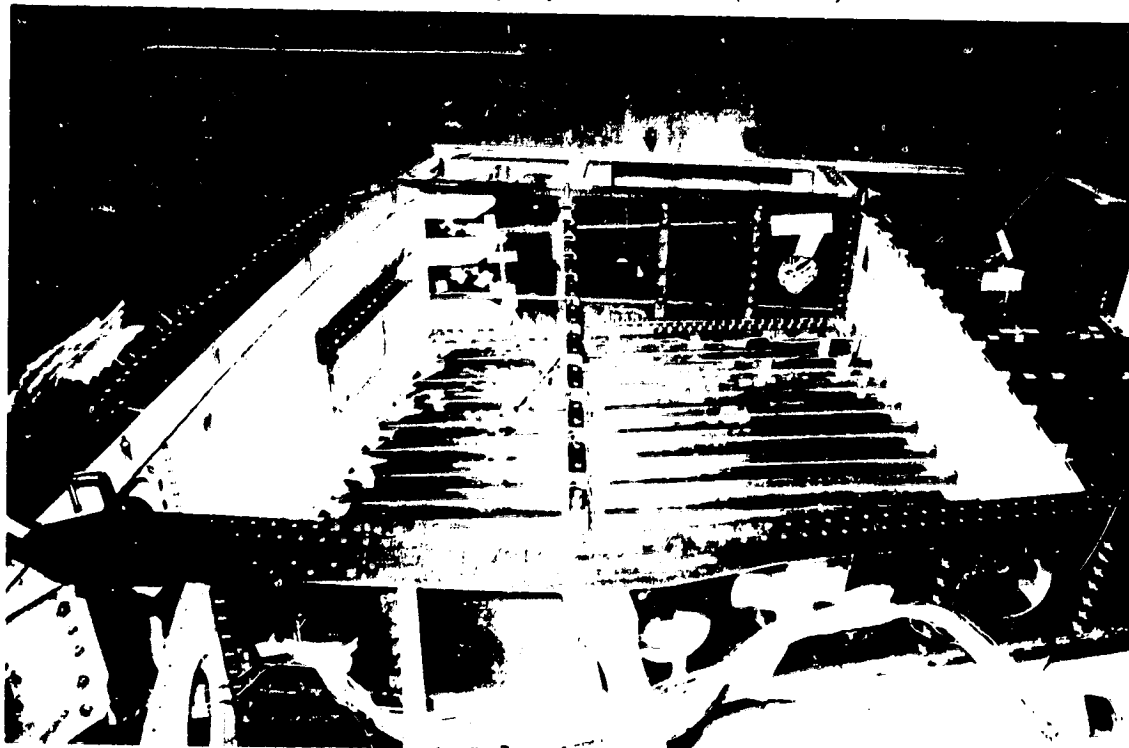
Figure 250. Stub Box—Front and Rear Spar, Lower Skin Panel, and Ribs With Instrumentation (Test 21)

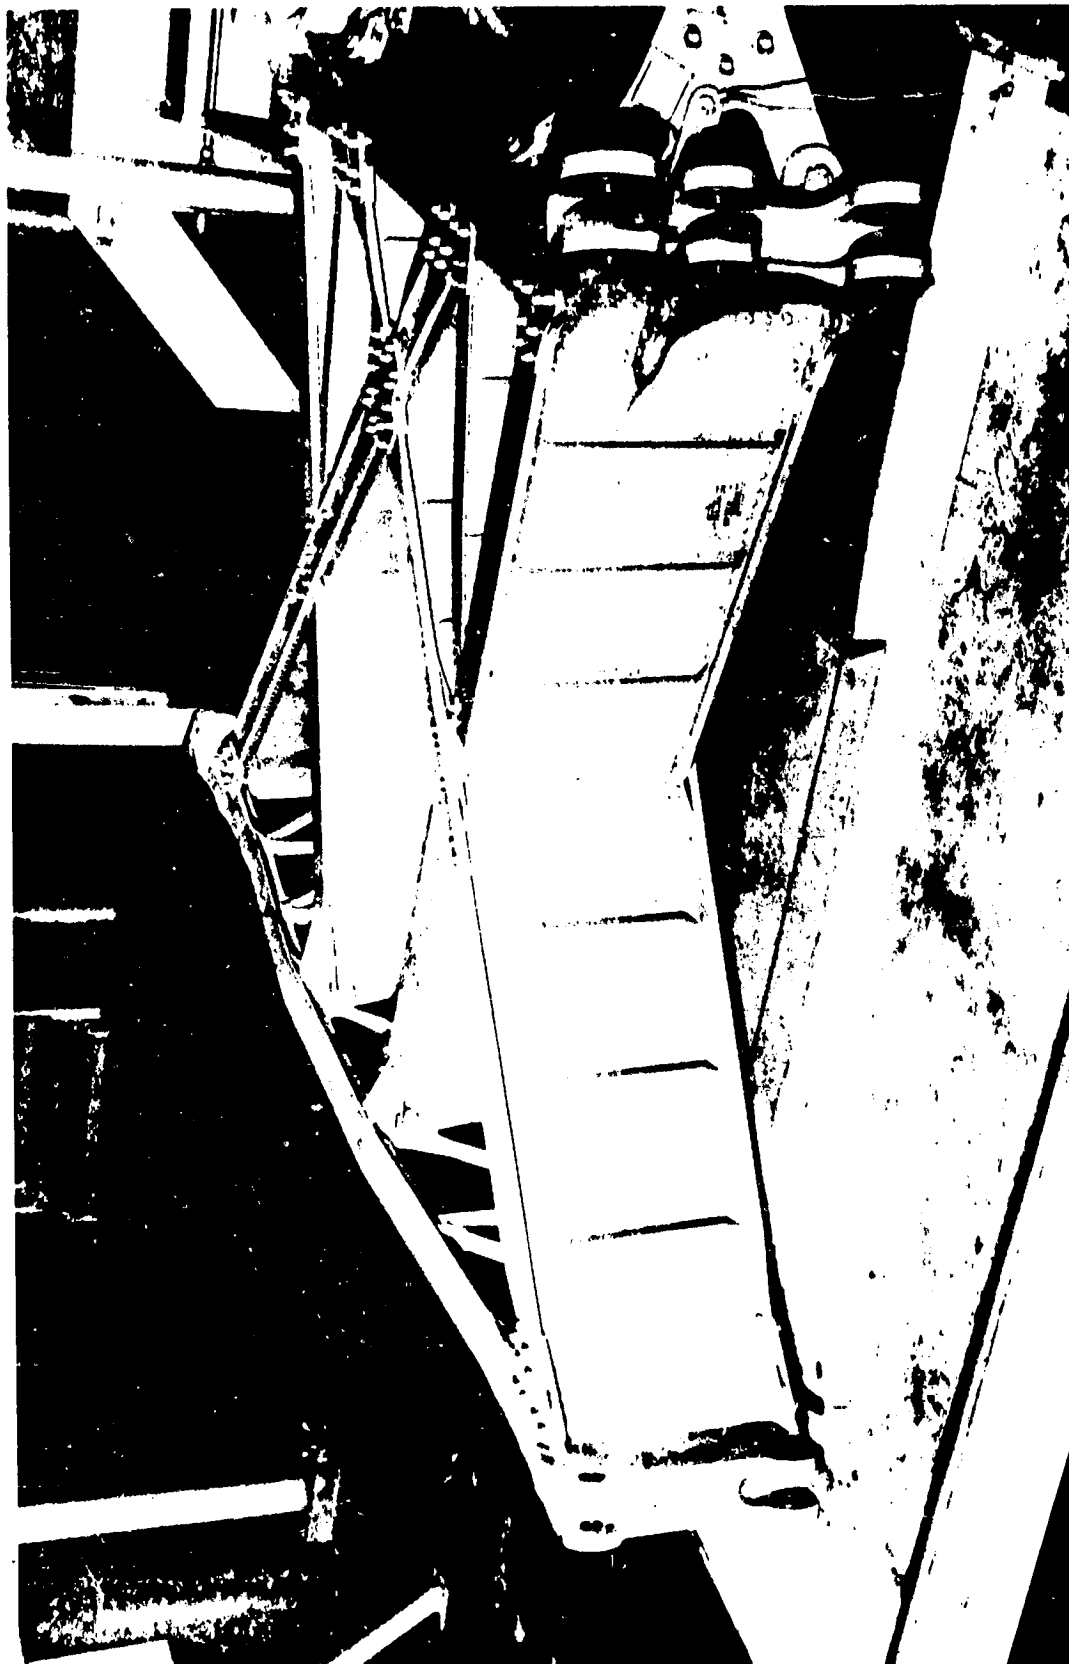
P4. Horizontal Stabilizer Center Section, Left-Hand Side View
